Washington Briefing  
Deepwater Horizon Interim Incident Investigation

24<sup>th</sup> May 2010

# Macondo Well Diagram – Key Components & Critical Factors

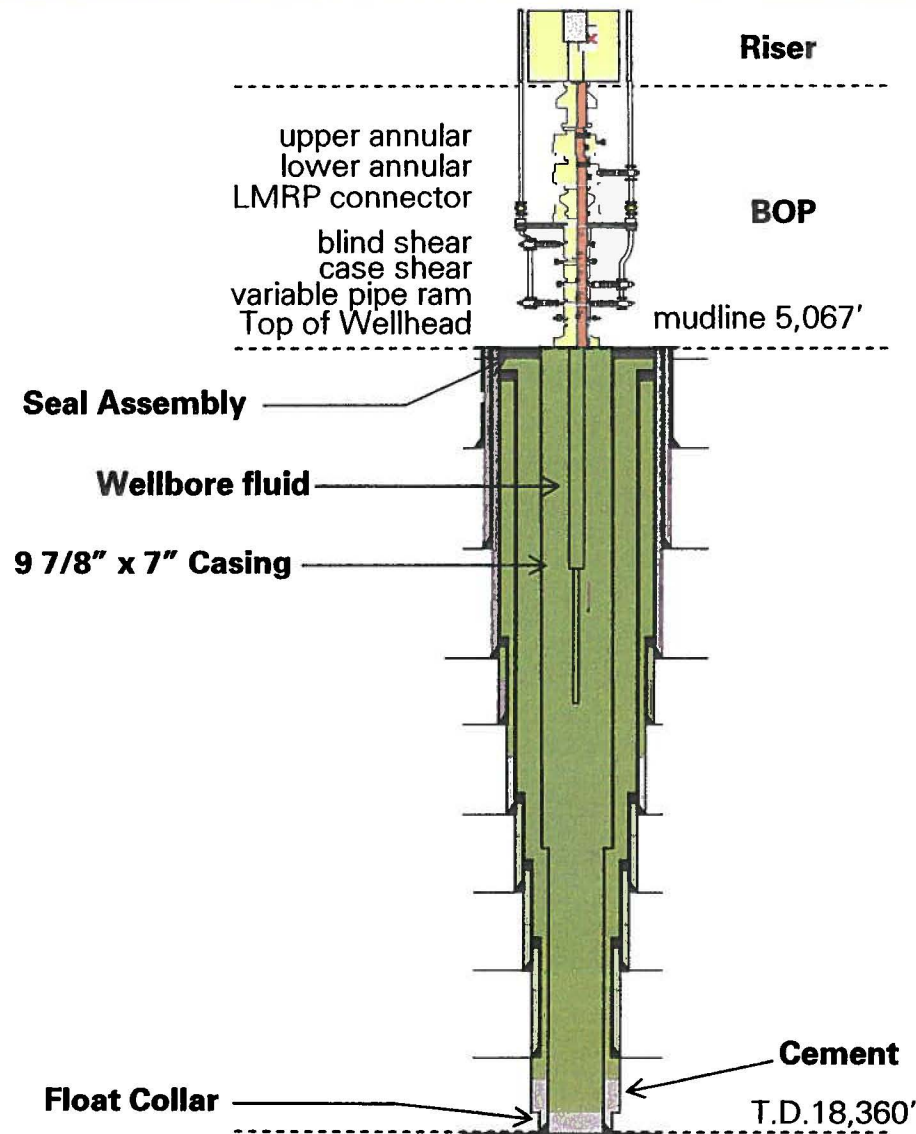
1. Loss of Integrity of the 9 7/8" x 7" casing created a path for hydrocarbon (HC) influx
2. Unrecognized well conditions
  - Influx unrecognized - Integrity test failed to identify communication with the reservoir
  - Operations allowed HC influx to enter and move up the well bore – *well became capable of flowing*
  - Response failed to control the well
3. BOP & Emergency Systems failed to isolate the HC source
4. Gas plume ignited

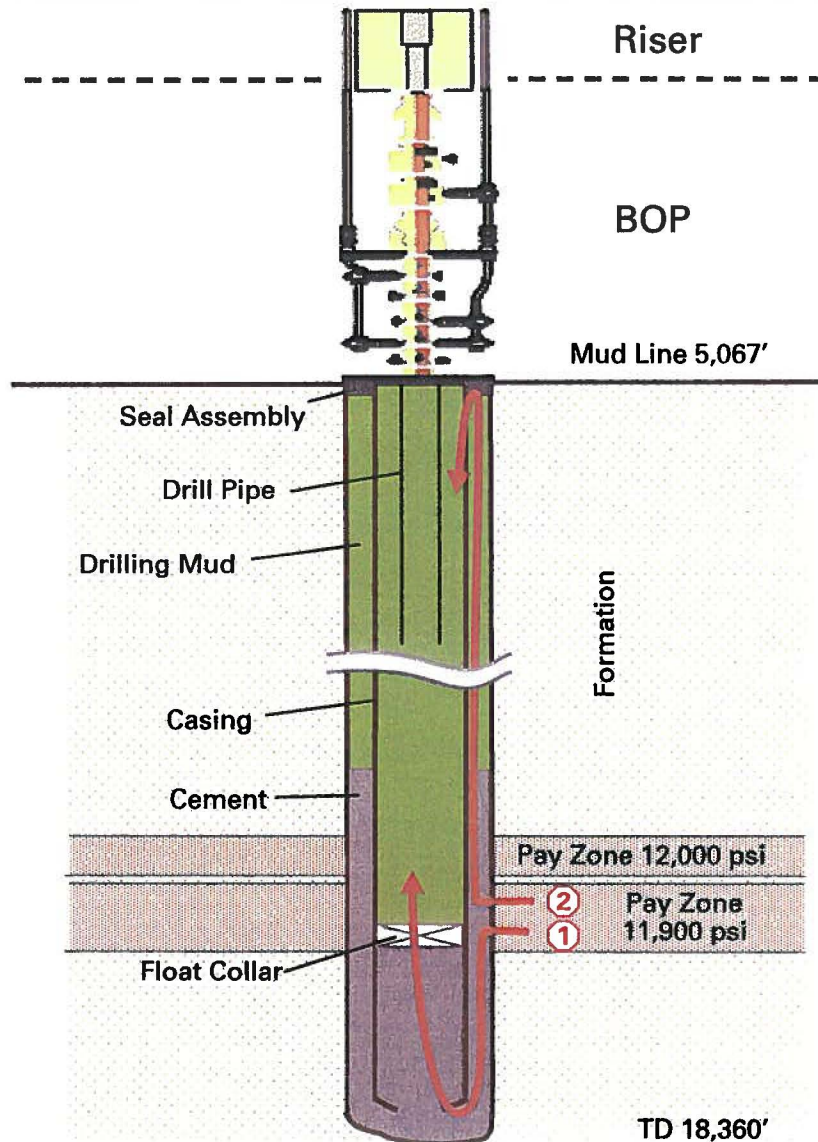
## Loss of Integrity of 9-7/8" x 7" Casing

- Cement failed to isolate the reservoir
- The float collar (1) or the seal assembly (2) leaked

- Review design and execution of the cement job
- Review design and installation of casing shoe track and seal assembly
- Laboratory testing of float collar
- Detailed well dynamic modeling to assess likely influx point

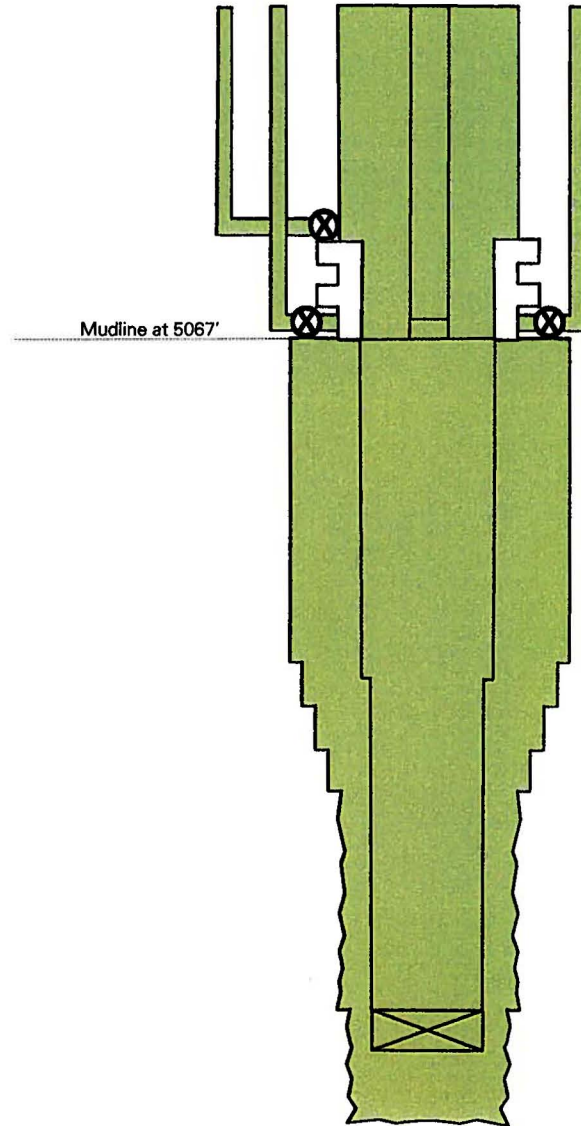
# Run Casing – Convert Float Equipment

Data
<ul style="list-style-type: none"><li>• Run 7" x 9-7/8' production casing<ul style="list-style-type: none"><li>– Crossover at 12487'</li><li>– Float Collar at 18114'</li><li>– Shoe at 18304'</li><li>– 56' of rat hole</li></ul></li><li>• Laid out three joints of 7" due to damaged threads</li><li>• Saw 10k weight bobble at 18218 (only time string took weight during run)</li><li>• 9 attempts to convert float equipment<ul style="list-style-type: none"><li>– Sheared at 3142 psi vs 500-700 psi design</li></ul></li></ul>

Interpretation
<ul style="list-style-type: none"><li>• Circulating pressure below normal after shearing float collar</li></ul>

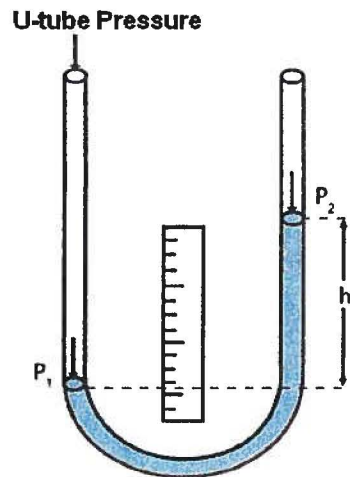
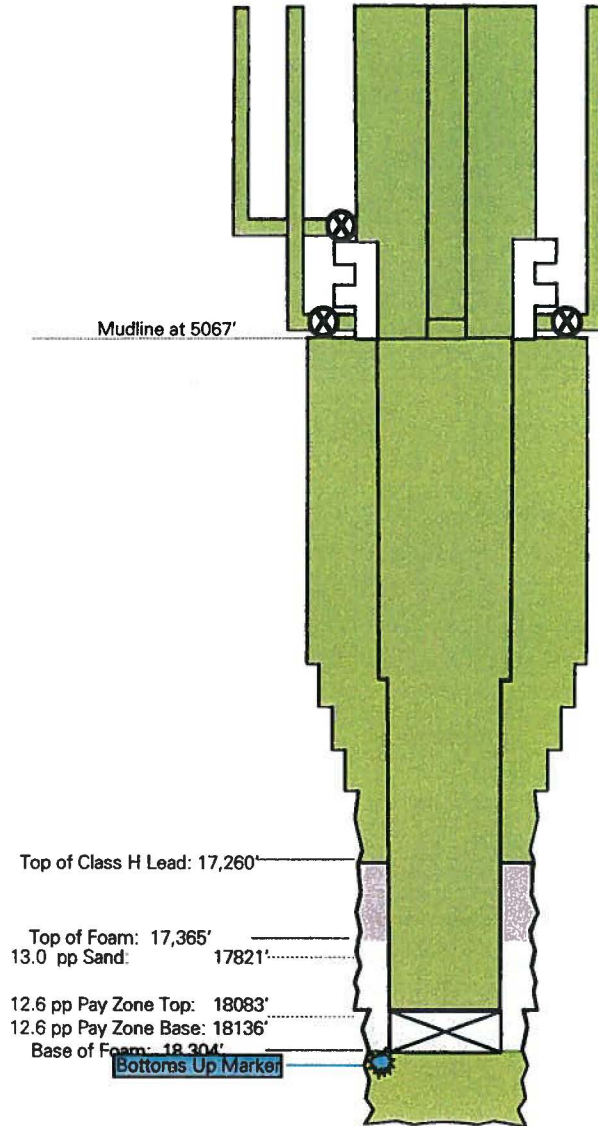
# Cement Job

- Circulate 342 bbl before cement job
- Pump nitrified foam cement
  - Pumped 60 bbl cement
- Estimated TOC at 17260'
- Bumped plug with 1150 psi
  - Cement in place at 00:35
  - Bled back 5 bbls to 0 psi
  - Minimal calculated U-tube pressure after job (nearly balanced)
- 14.0 ppg mud in rathole with 16.7 ppg cement in shoe track

- Job pumped per plan – no cement losses observed
- Minimal U-tube may have prevented definitive float test
- Potential for contamination of cement in shoe track due to density difference between cement and mud

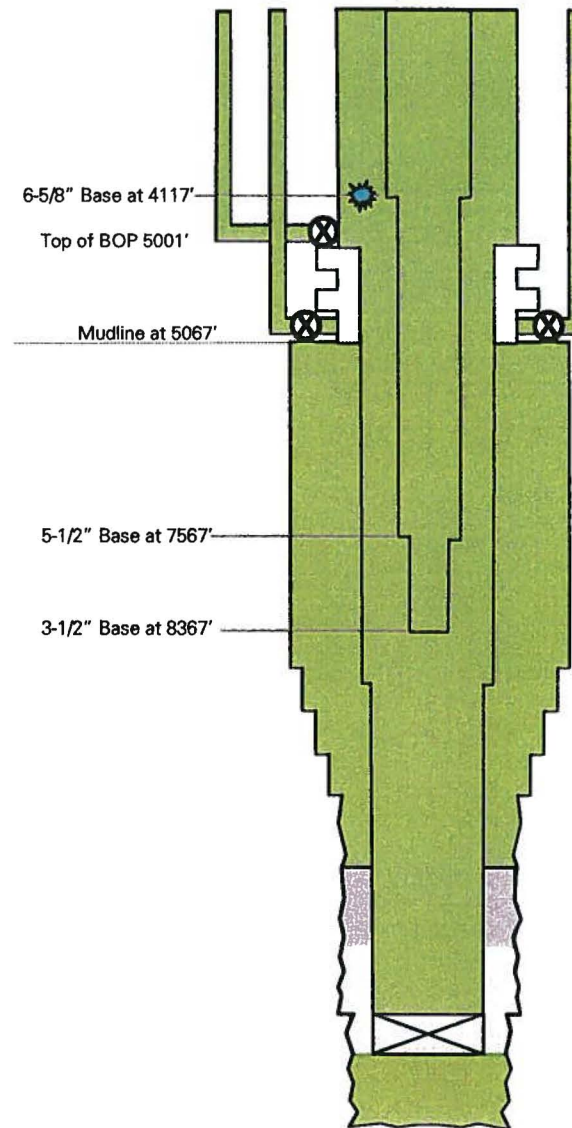
# Finish Trip in Hole

<u>Interpretation</u>
<ul style="list-style-type: none"><li>• <b>The approach to transferring mud may have impaired pit monitoring over next 4 hours</b></li></ul>

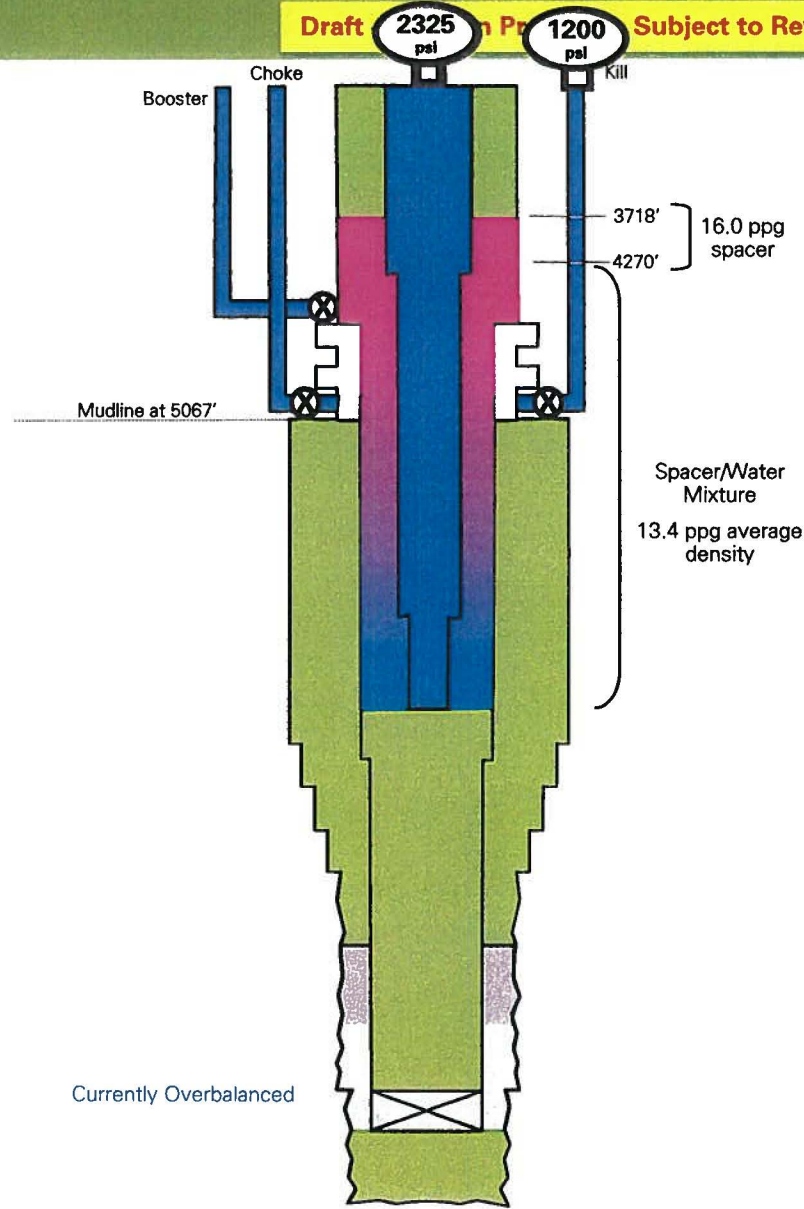
# Pump Seawater

Data
<ul style="list-style-type: none"> <li>Pump 352bbbls seawater                             <ul style="list-style-type: none"> <li>Not enough to get spacer above BOP</li> </ul> </li> <li>2325 psi static pressure after pumping                             <ul style="list-style-type: none"> <li>Calculated U-tube is 1628 psi</li> </ul> </li> </ul>

Interpretation
<ul style="list-style-type: none"> <li>Higher than expected static pressure may indicate large spacer-to-water interface</li> <li>Significant solids settling expected once pumps stop</li> <li>High gel strength with 100% spacer</li> </ul>

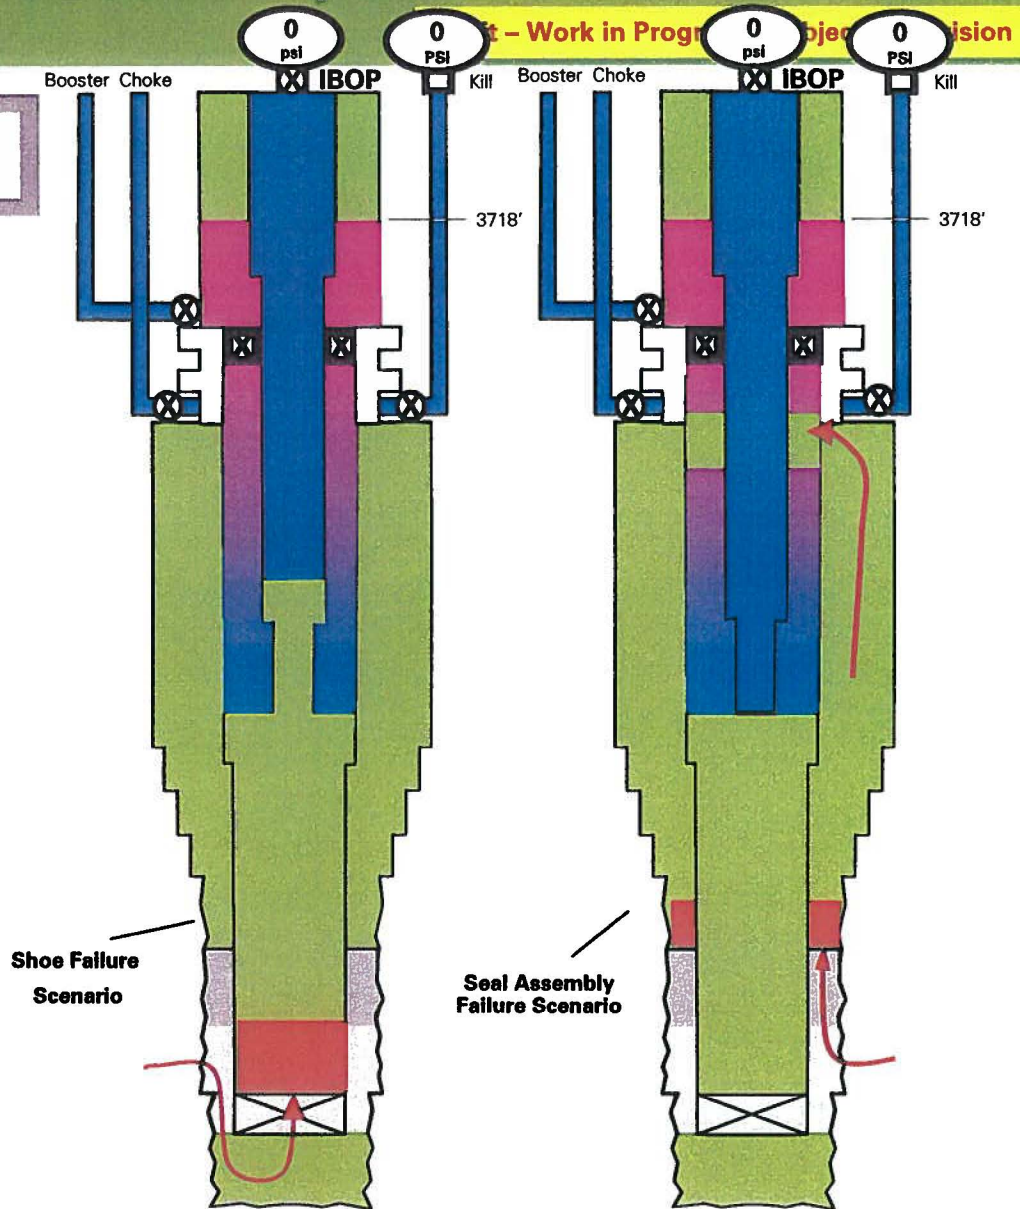
# Bleed from 1202 to 0 psi

- Witness statements indicate 15 bbls taken at this bleed
  - Normal compressibility would be approximately 5 bbls
  - Influx from the well is suspected

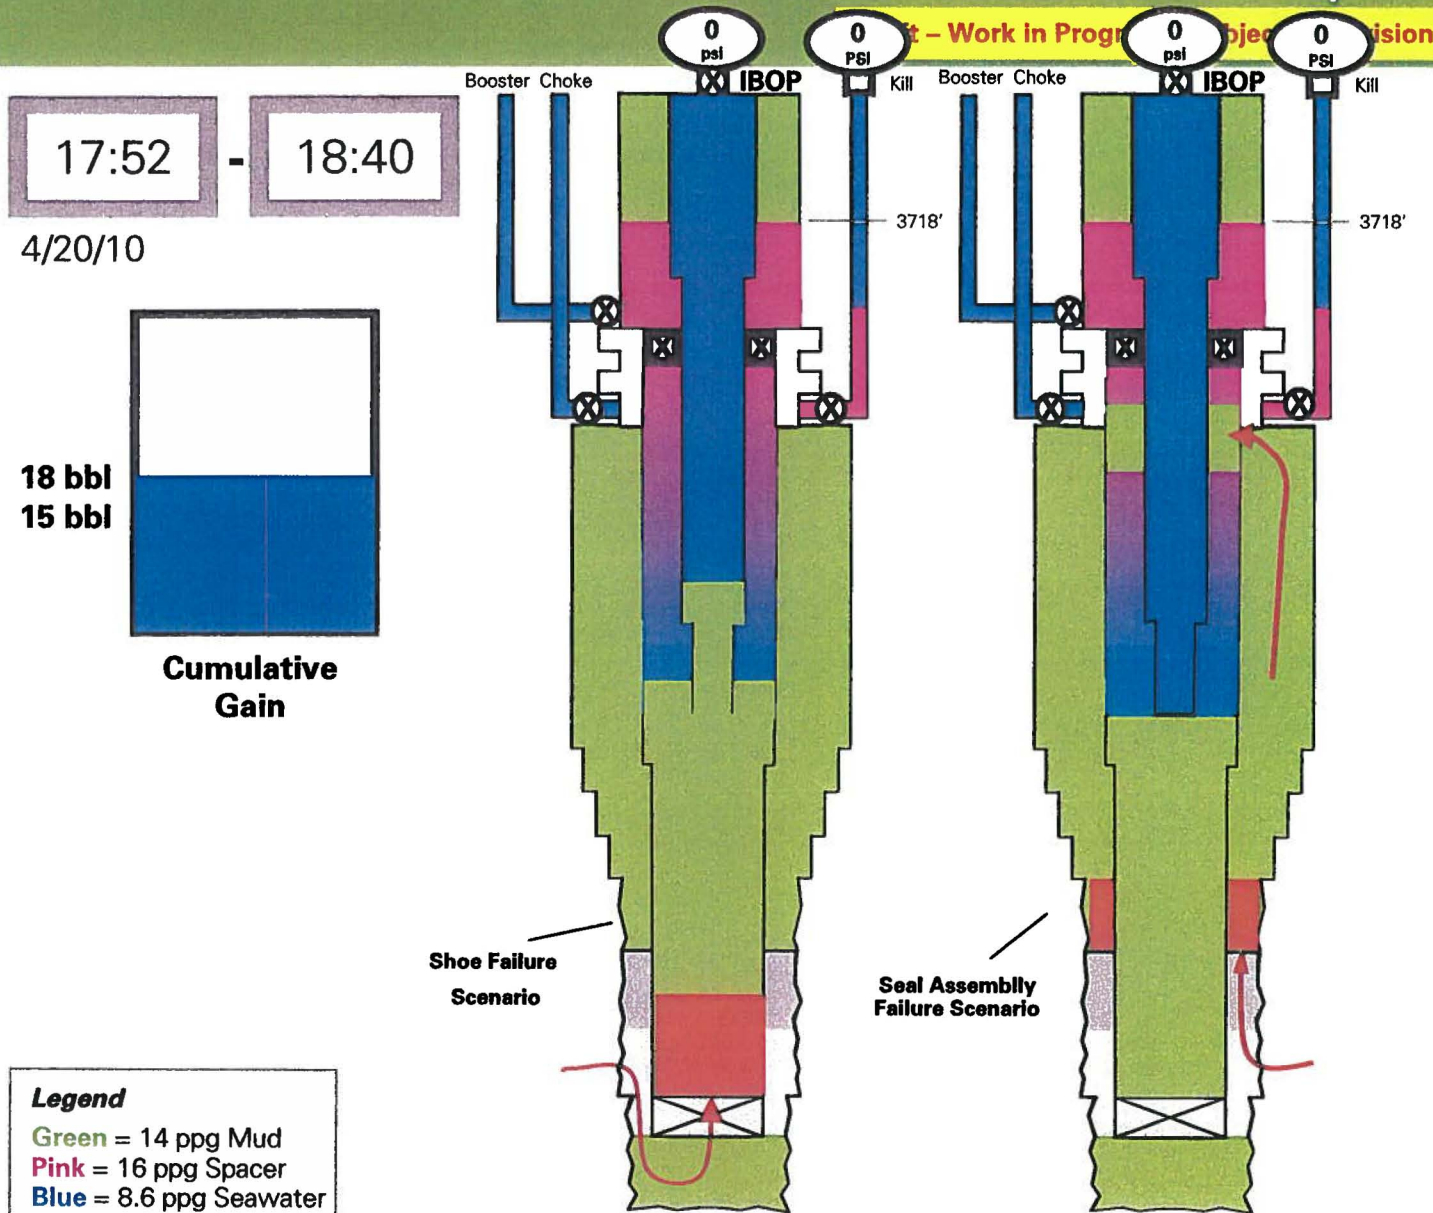
# Bleed Kill Line / Pressure Builds Gradually

Data
<ul style="list-style-type: none"> <li>Pressure monitored through cement unit quickly rises to 790 psi and falls</li> <li>Pressure slowly builds from 0 to 1400 psi over 31 minutes</li> </ul>

Interpretation
<ul style="list-style-type: none"> <li>Start monitoring drillpipe pressure at cement unit</li> <li>Bleed 3-15 bbls from kill line to cement unit</li> <li>Cementer witness statement that well continued to flow and spurted</li> <li>Shut kill line and see pressure build</li> </ul>

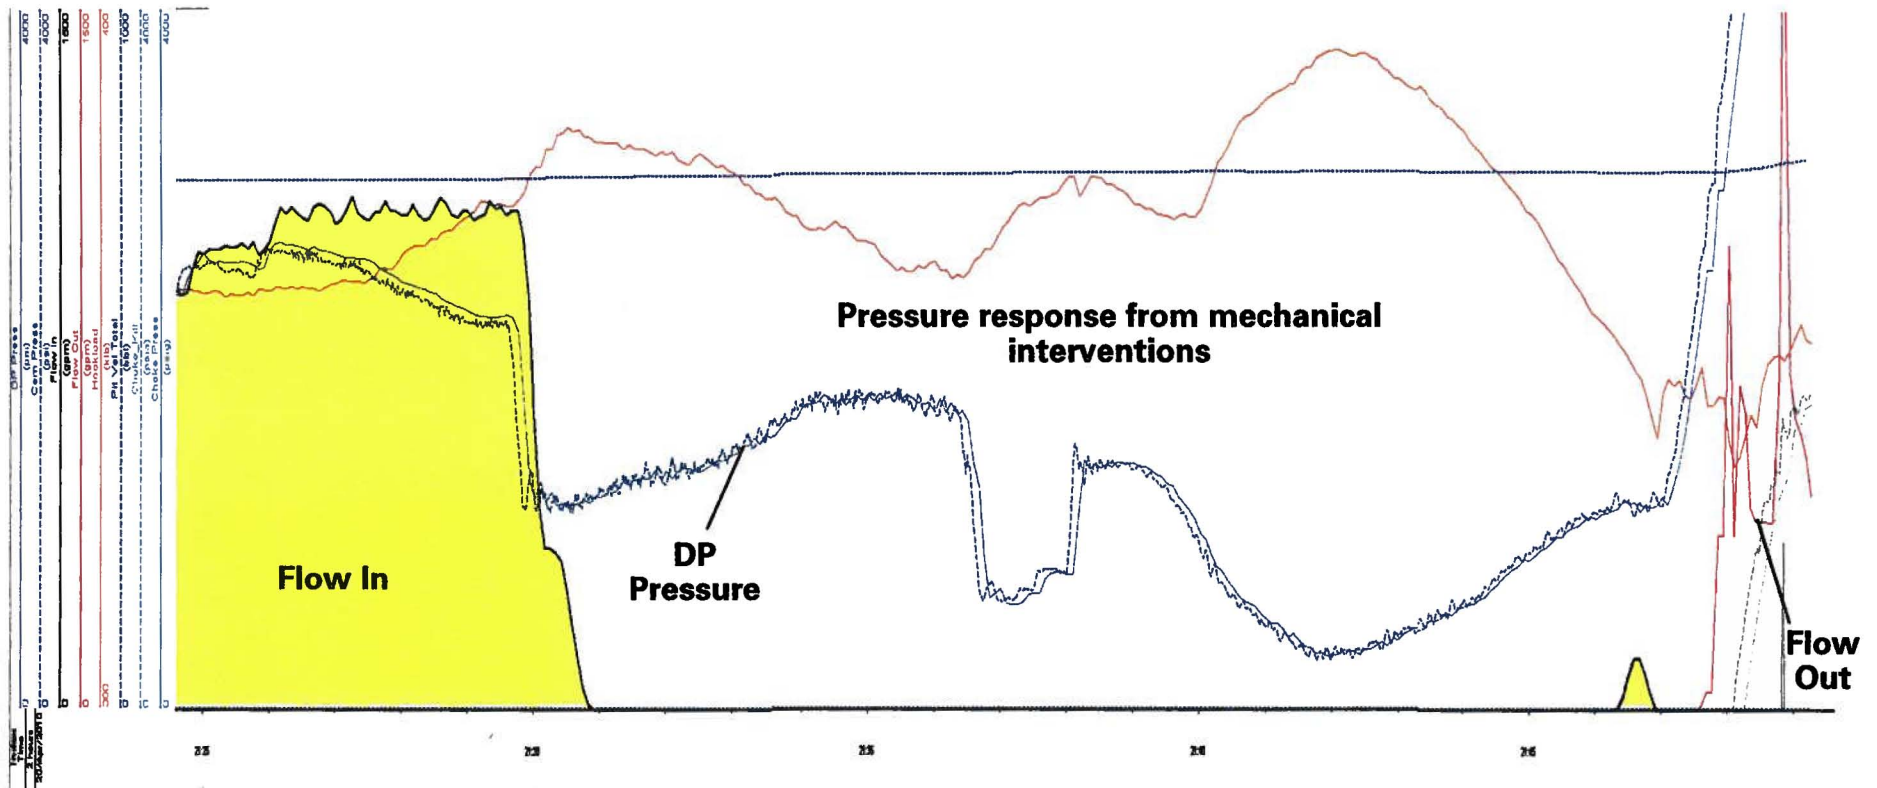
# Final 18 Minutes

Data lost, suspect explosion
