Toussaint L'Ouverture Port-Au-Prince International Airport Haiti

Image: GeoEye MS/Pan Merged
Date: 13 Jan 2010

Damage Assessment January 2010

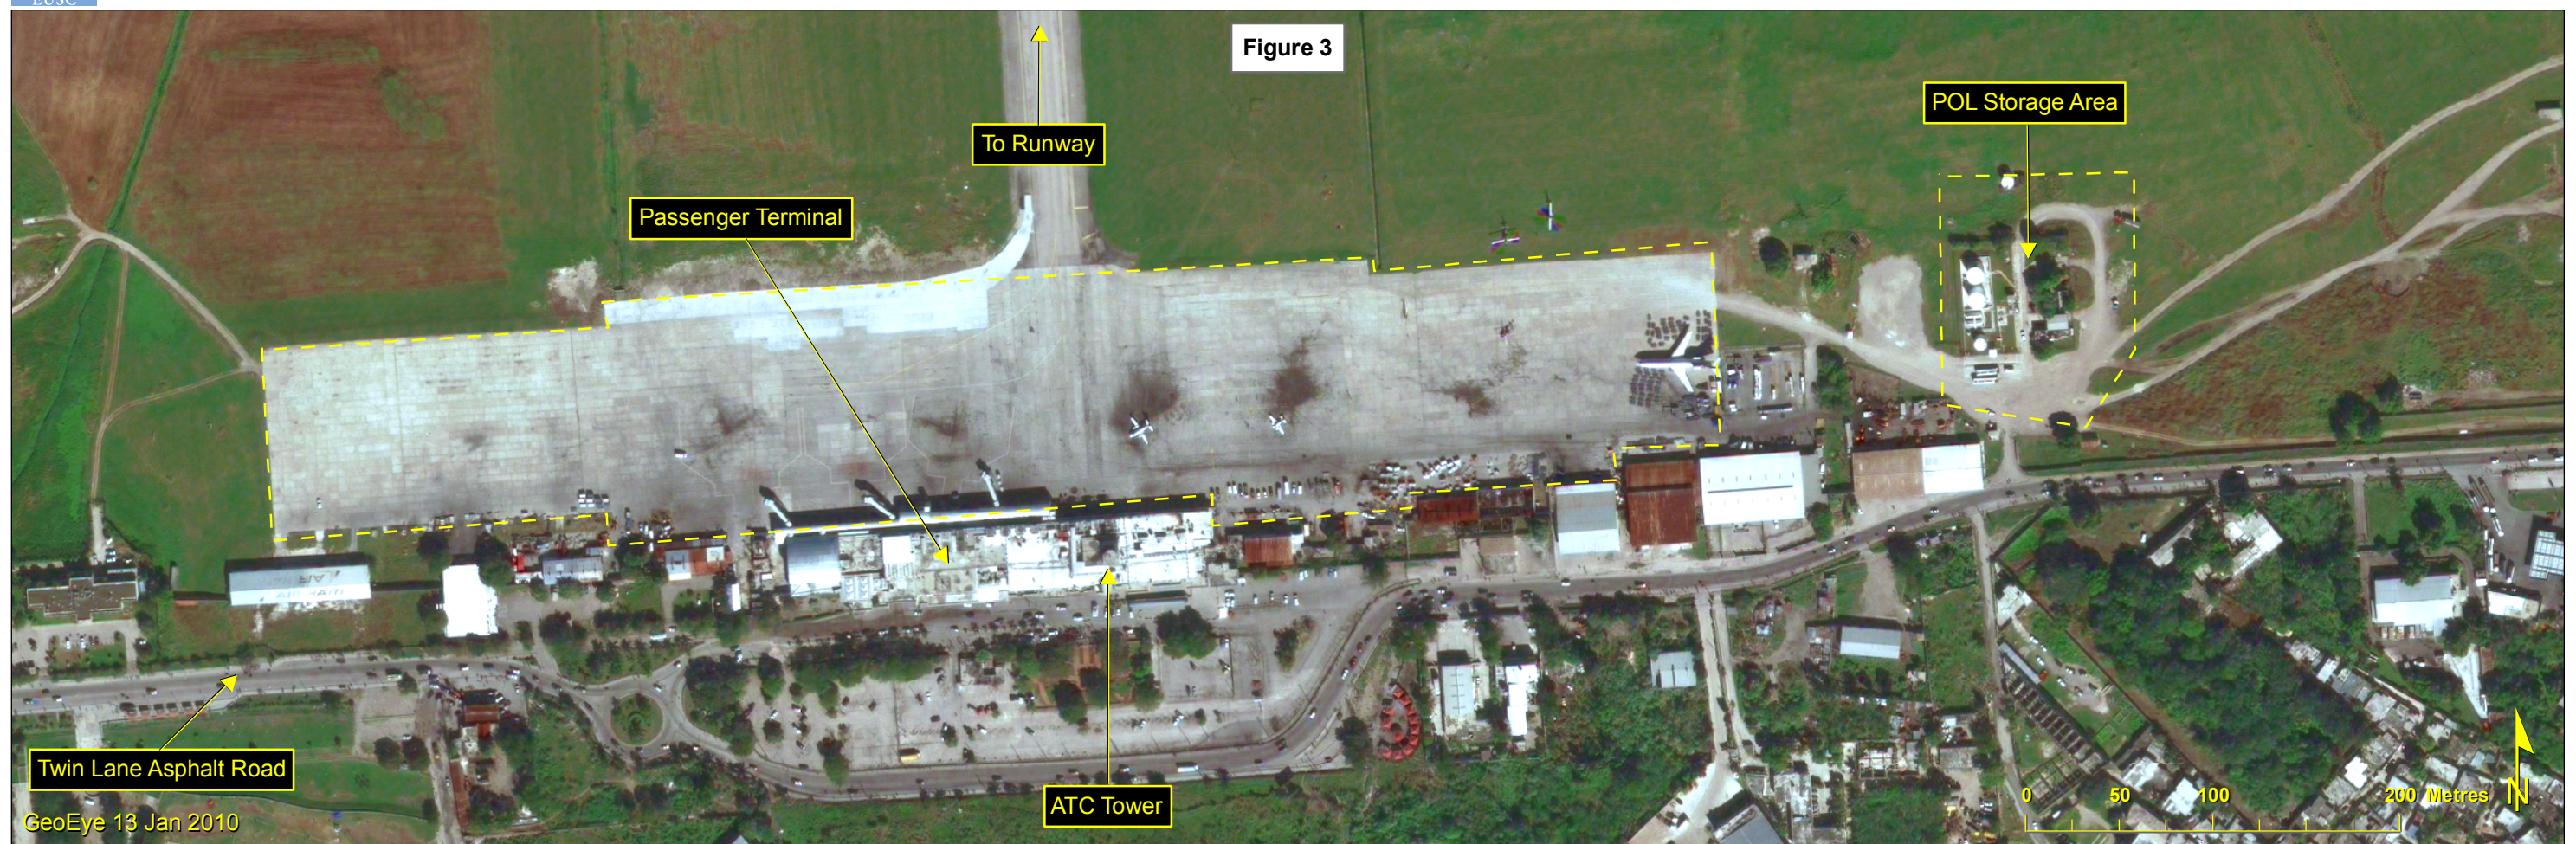
Aircraft activity included, two light helicopters, two executive jets and a single, probably unserviceable Boeing 727 airliner observed on the passenger terminal aircraft parking apron (Figure 3). On the grass area adjacent this, two light transport helicopters were observed with their rotor turning. On the central aircraft parking apron, 24 aircraft were observed. These comprised of 13 twin, propeller engine aircraft, 10 single, propeller engine aircraft, an executive jet and three light helicopters (Figure 4). On the apron located to the east of the UN Logistics Base (1) a Casa C212 Aviocar transport aircraft and a Dash 7 transport aircraft were parked. In addition, four Mi 8/17 'HIP' transport helicopters and five UH-1N Iroquois transport helicopters were also observed (Figure 5). Airborne and approaching the parking apron was a single light helicopter.

The passenger terminal is equipped with three passenger bridges and also accommodates the air traffic control (ATC) tower on its roof. Adjacent to the passenger terminal are numerous cargo transshipment buildings (Figure 3). To the east of the passenger terminal is a POL storage area with three flat-roofed POL storage tanks (Figure 3). In addition, a UN logistics base is contained in a compound to the west of the south eastern aircraft parking apron. The compound contains a hospital, numerous storage and support buildings and vehicle parking areas occupied by light-toned UN vehicles (2) (Figure 5). The airport navigation and landing aids include an ILS system and PAPI system at the western end of the runway. The airport is partly wall and partly fence-secured with watch towers and a perimeter patrol track. The main access to the airport is via a twin lane asphalt road leading to the airport terminal.

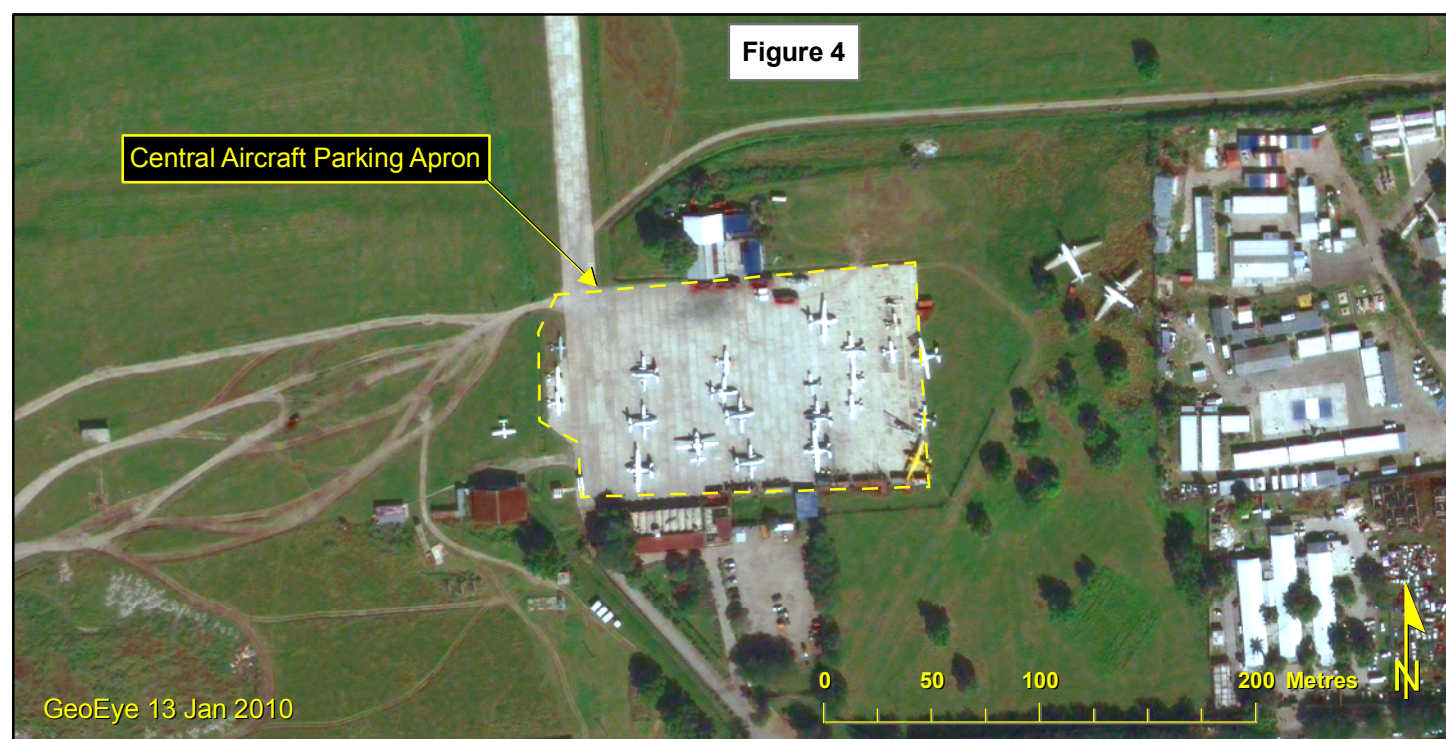
Toussaint L'Ouverture, Port-au-Prince International Airport has a single, concrete runway known as RWY 10/28 with usable length of 3,000 m and a width of 50 m. The runway has a turning area 650 m from the eastern end and a second turning area at the western end. Three link taxiways connect the runway to three aircraft parking aprons. These aprons comprise of a concrete apron of 770 m by 110 m, in front of the airport passenger terminal (Figure 3), a centrally located, concrete apron of 170 m by 100 m to the south of the runway (Figure 4) and a concrete apron of 150 m by 160 m to the SE of the runway (Figure 5).
