Critical Infrastructure Information Notice- CIIN-08-291-01

Possible Counterfeit Cisco Routers

Product Anomaly Inspection: Cisco 2600 Router Series: (2610XM, 2611XM, 2620XM, 2621XM)

Product Anomaly Inspection: Cisco 1721 Modular Router

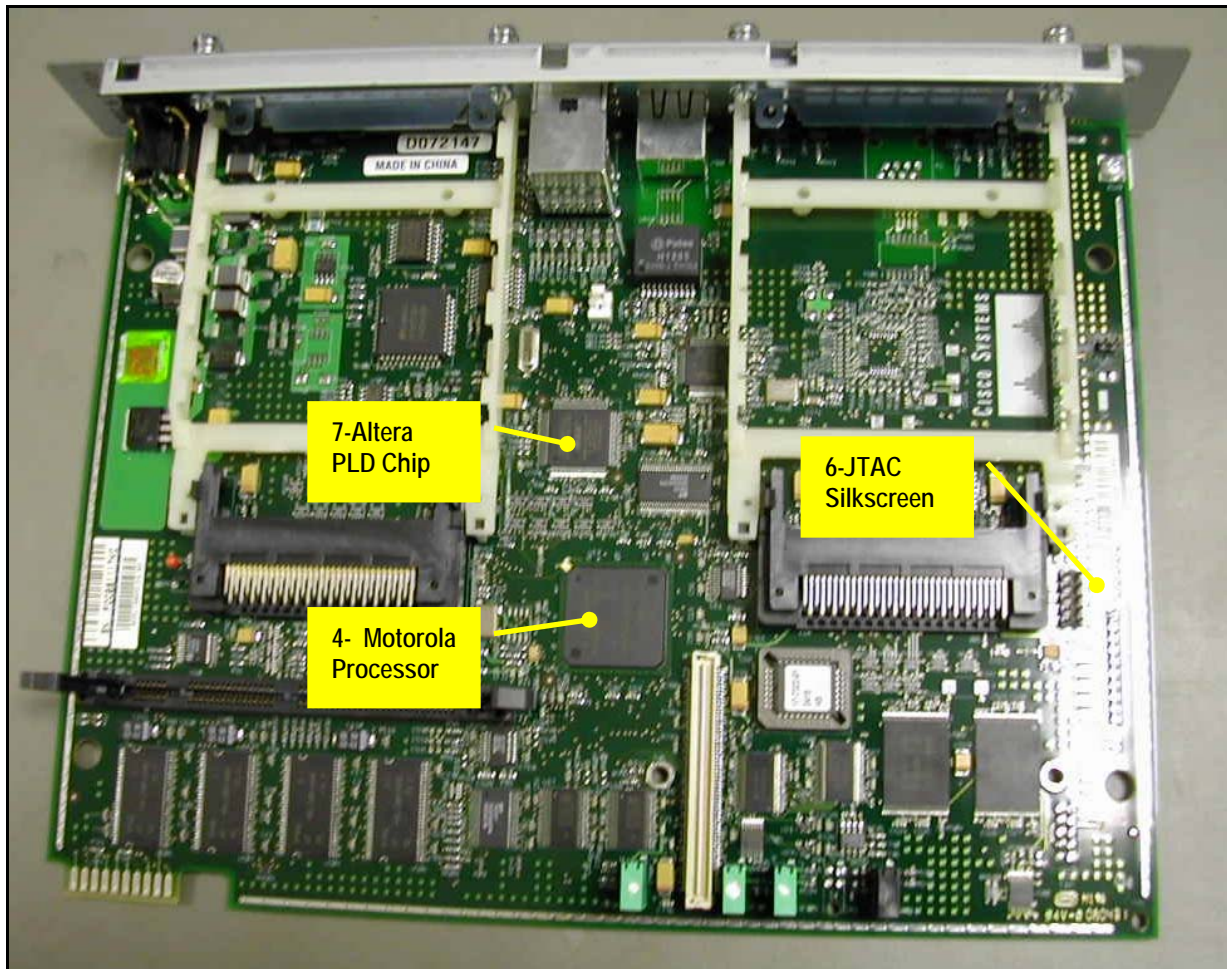
Figure 3. Cisco 1721 Router (Internal PCB)

Figure 3 shows a global view of location attributes.

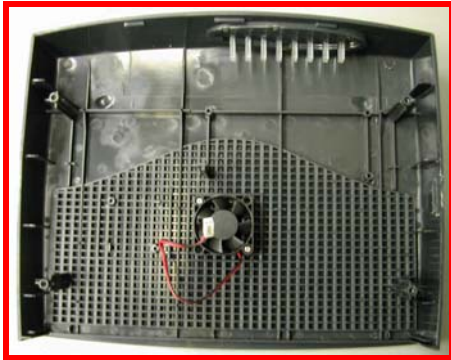
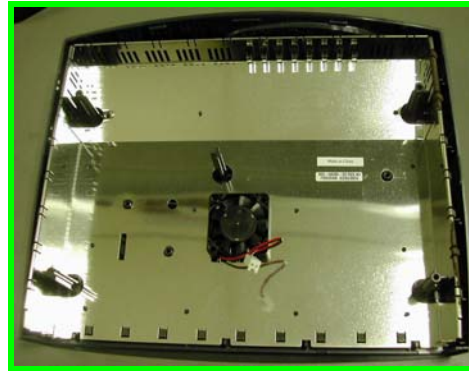
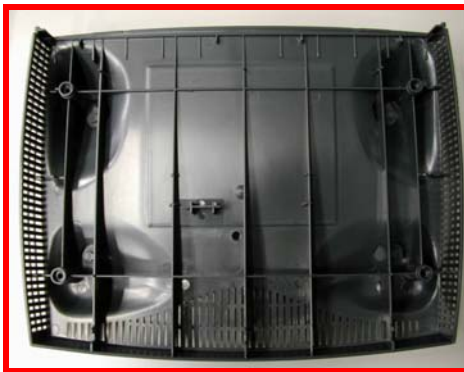
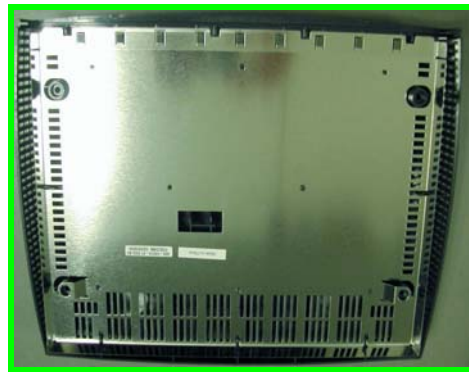
Figure 4. Compliant Cisco 1721 router has metal RFI shielding.

Description: The Cisco 1721 Router has metal Radio Frequency Interference (RFI) mitigation screens in the top and bottom halves of the chassis shell. The following illustrations depict compliant and non-complaint Cisco 1720 chassis shells.

Non-compliant 1721 chassis

Compliant 1721 chassis

Action: Divert Cisco 1721 product that has no metal RFI screens in the top and bottom of the chassis.

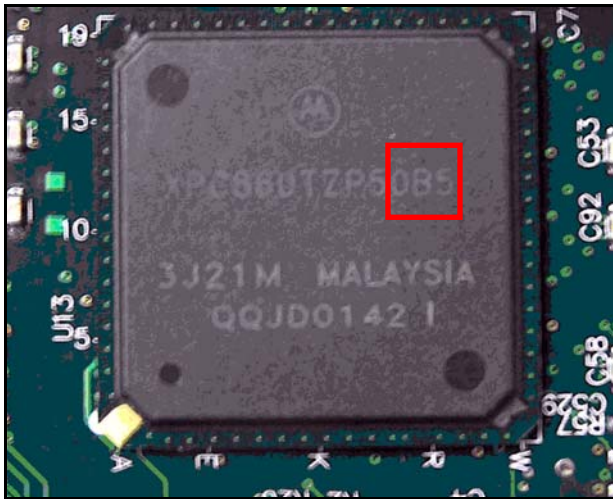
Figure 5. 1721: Non-compliant version ‘B’ Motorola processor.

Description: The design for the Cisco 1721 specifies a particular Motorola processor at position **U13** of the PCB, with part number **XPC860PZP50D4**. Certain non-compliant units have a similar processor with part number, with the letter **B** in the next to last position. Only a version **D** chip is correct. A unit that uses version ‘B’ of the chip is non-compliant.

Action: Examine the Motorola processor at position U13 of the PCB. Divert Cisco 1721 product with a “B” version of this as potential counterfeit.

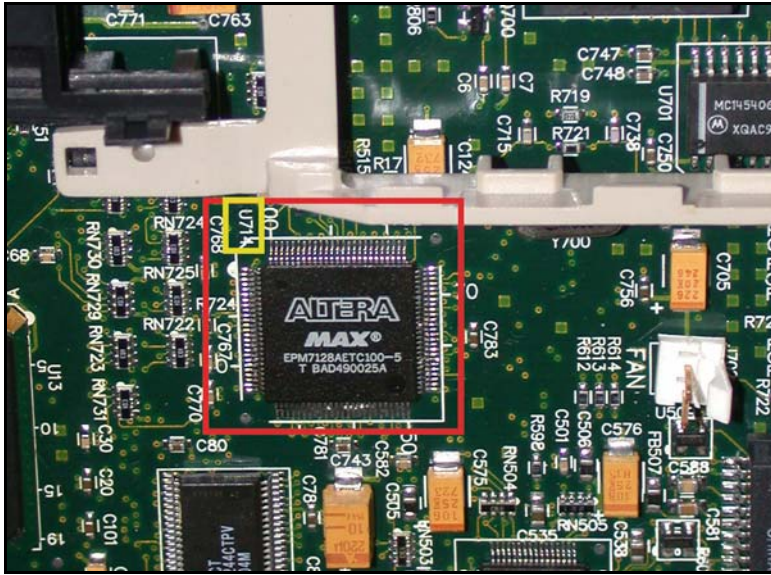
Figure 7. 1721: Non-compliant Altera PLD with Incorrect Speed

Description: The design for the Cisco 1721 Router specifies an Altera PLD with part number **EPM7128AETC100-7** in position U714 on the top of the motherboard. Certain non-compliant units have an Altera part of an incorrect version and speed grade. The part number on these chips is often either **EPM7128AETC100-5** or **EPM7128AETC100-10**.

Action: Examine the Altera PLD chip at position **U714** on the PCB. Divert Cisco 1721 product that does not use part number **EPM7128AETC100-7**.

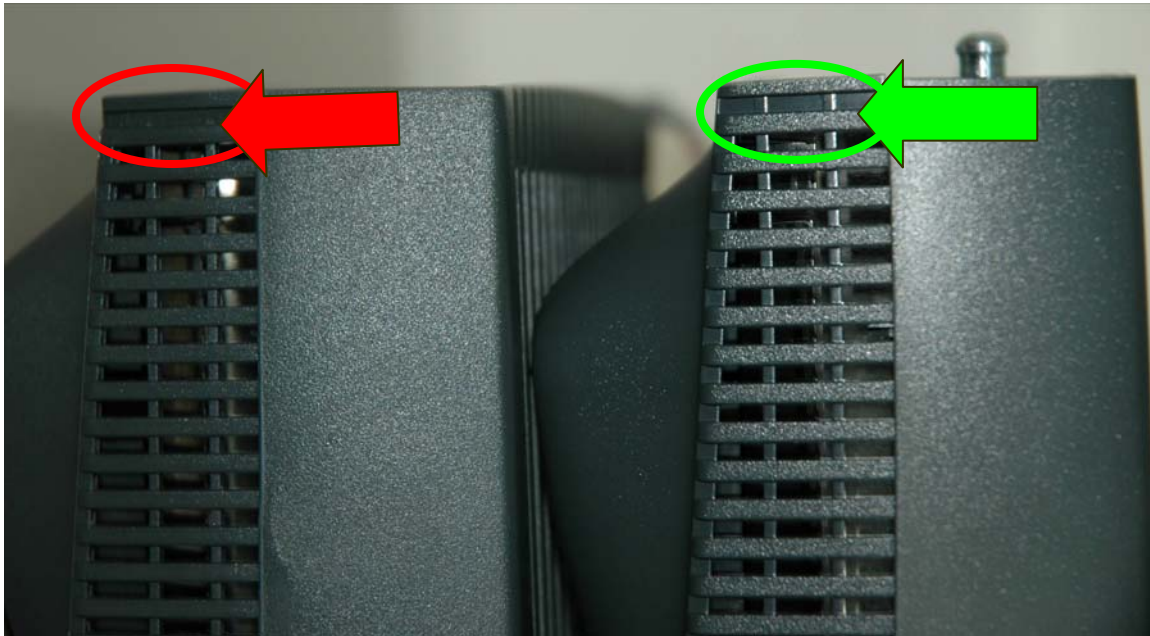
Figure 8. 1721: Non-compliant case (left), and compliant, with lines to end (right)

Description: On the Cisco 1721, two lines of plastic run horizontally and perpendicular to the vent slots along the sides of the case. These lines continue all the way to the rear of the chassis.

On non-compliant 1721 routers, the two plastic lines end prematurely, not continuing through the final slot at the rear of the casing.

Action: Examine the casing on the sides of the case to make sure the horizontal lines continue to the rear of the chassis. Divert a unit with case lines that end before the very rear of the chassis.

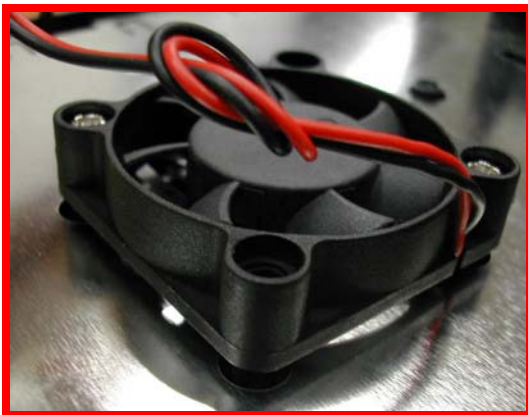
Figure 9. 1721: Non-compliant fan has no part number sticker

Description: On the Cisco 1721, the fan in the top half of the chassis shell has a sticker with a Cisco part number on it. A non-compliant product does not have this sticker, or any other indication of part number, on the fan.

Action: Divert Cisco 1721 product with no part number on the fan as potential counterfeit.

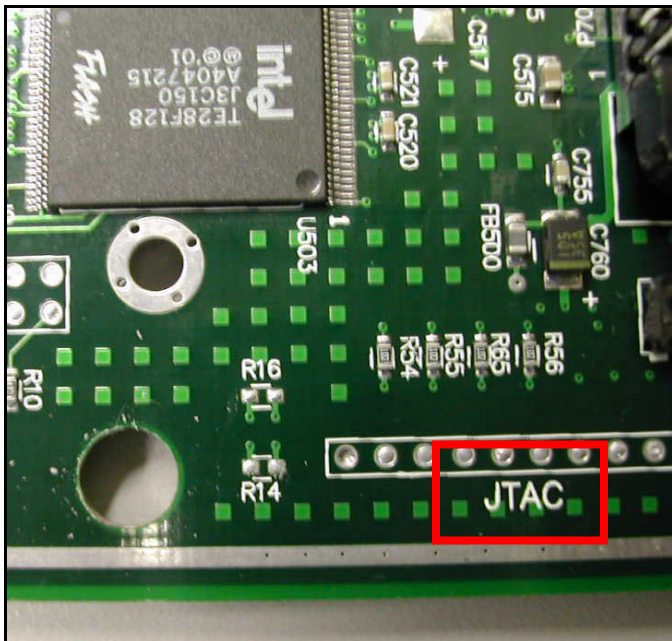
Figure 11. 1721: PCB with test points misspelled “JTAC”

Description: On Cisco 1721 units, the test points on the PCB are labeled “JTAG”. The test points are a row of contacts on the PCB at position **J1**, and are completely filled with silver-colored solder on genuine units. Certain non-compliant units have the test point label misspelled “JTAC”. The test points on an anomalous product are bare copper or incompletely tinned with solder.

Action: Examine the area around the test point label at position **J1** on the PCB. Divert Cisco 1721 product with test points with incomplete solder, or with the “**JTAC**” label spelling.
