ISSF 2010: Session 6

**Integrity Inspection of Dry Storage Casks
and Spent Fuels at Fukushima Daiichi
Nuclear Power Station**

Yumiko Kumano

Tokyo Electric Power Company

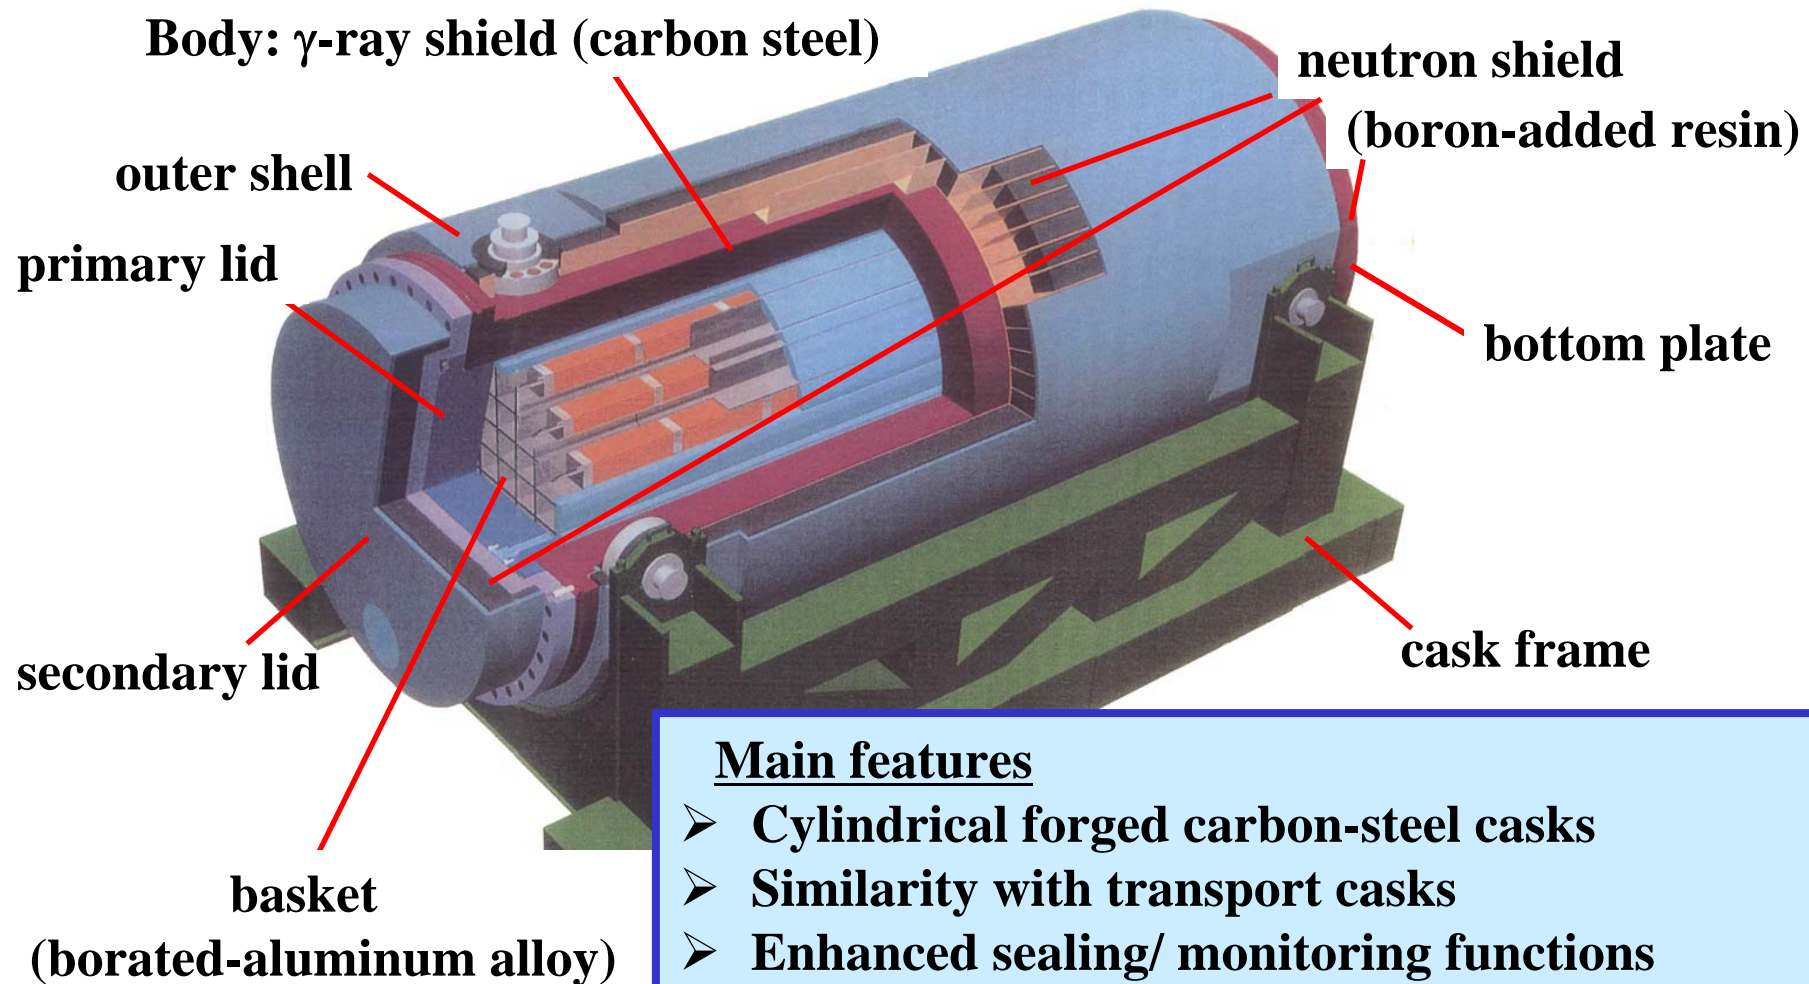
Structure of Dry Cask

- Cylindrical forged carbon-steel casks
- Similarity with transport casks
- Enhanced sealing/ monitoring functions
- Inner gas substituted with helium
- Steel for γ -ray shield/ resin for neutron shield
- Borated-aluminum alloy basket for sub-criticality

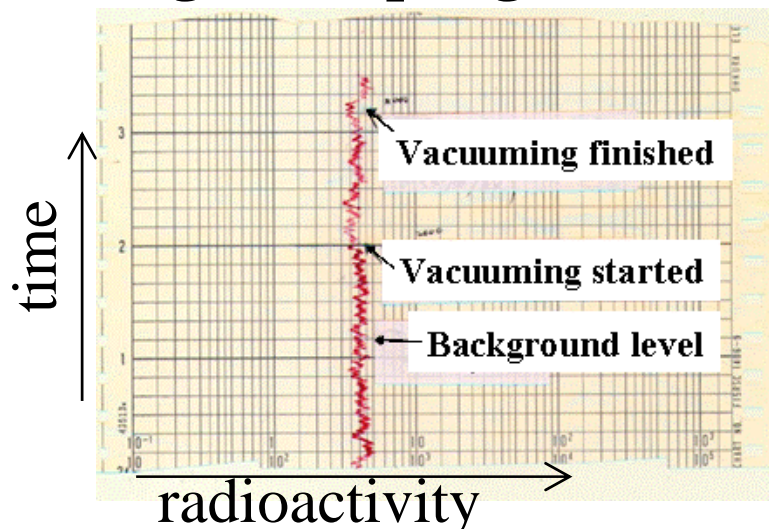
➤ Inner gas sampling for measuring Kr-85 concentration

⇒ No leak of Kr-85 from the spent fuel was observed based on the measurement of radioactivity of the sampled gas.

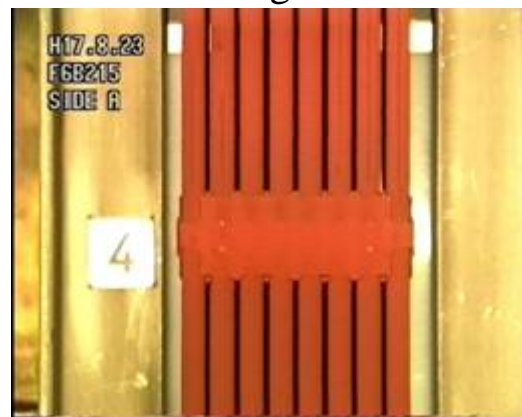
8/Sep/1995

➤ Visual inspection of a fuel assembly

⇒ No signal of any defect was observed.

Target: 8X8 BWR assembly (approx.28 GWd/t)
