# Terrorist Tactics

November 20, 2008

## Attack on Indian Embassy Kabul, Afghanistan

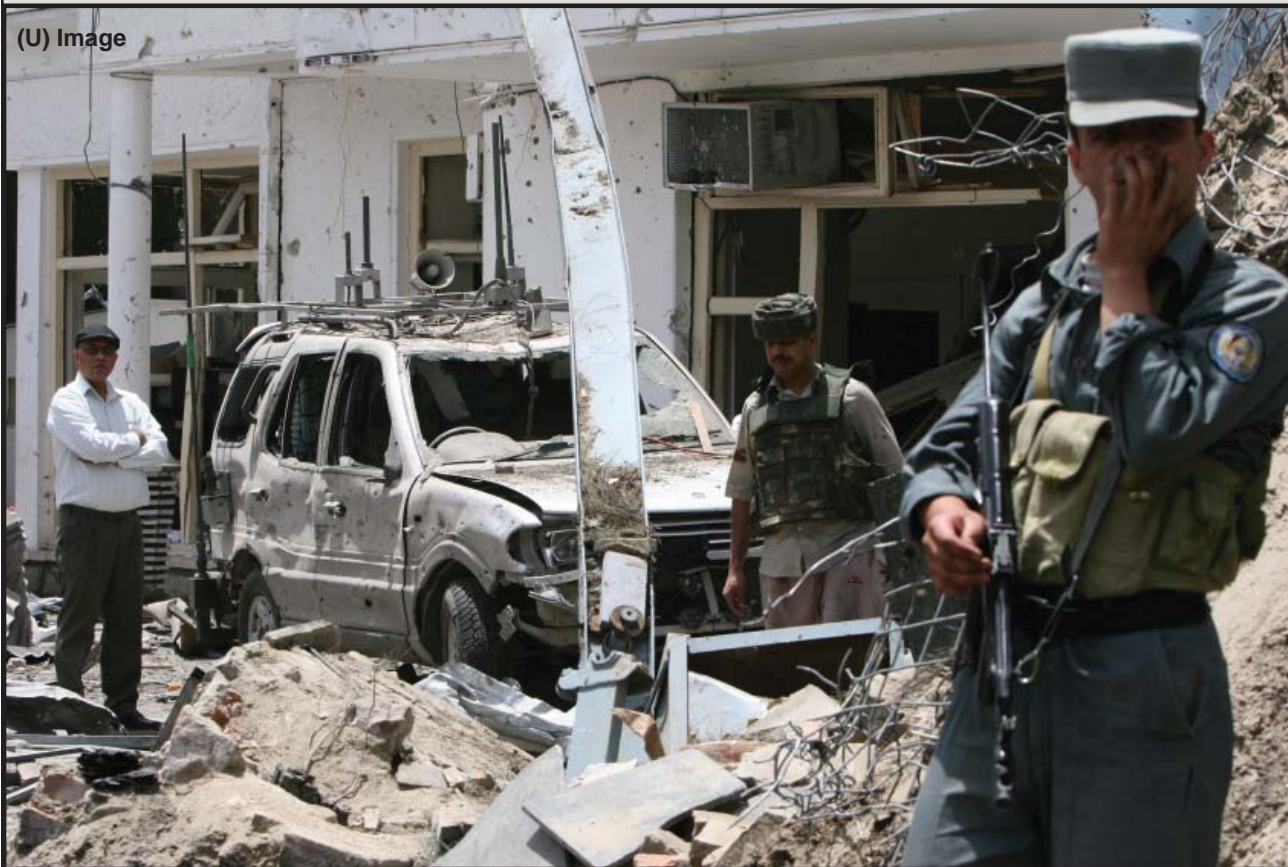
(U) Security forces stand guard at the Indian Embassy in Kabul July 7.
