Washington Briefing  
Deepwater Horizon Interim Incident Investigation

24<sup>th</sup> May 2010

# Macondo Well Diagram – Key Components & Critical Factors

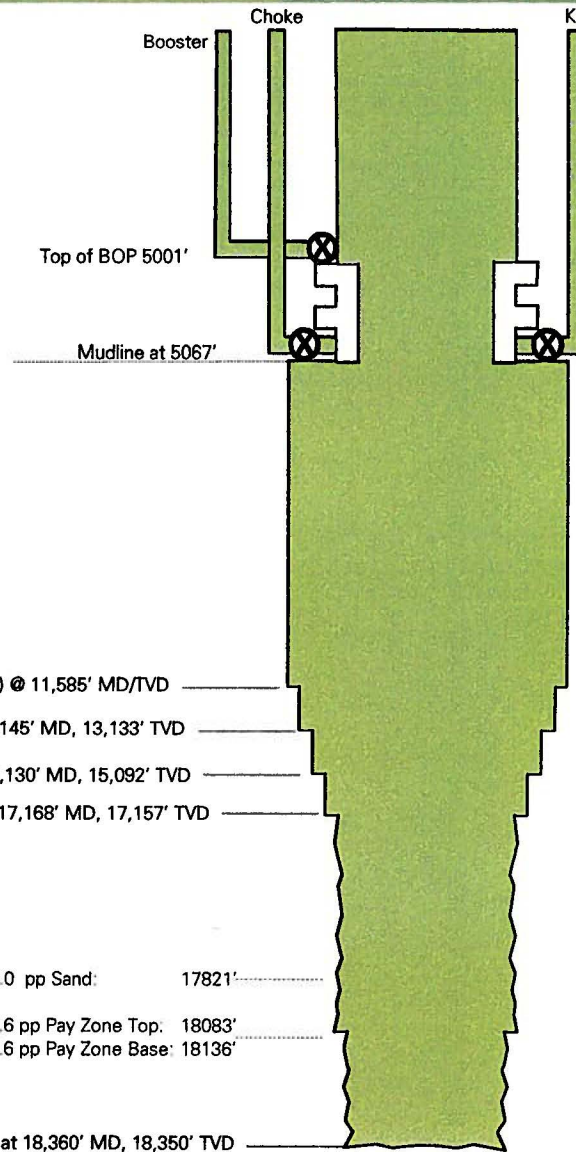
4/9/10 - 4/15/10

Last BOP pressure test: 4/10/2010  
All tests passed

Data
<ul style="list-style-type: none"> <li>Finish drilling                             <ul style="list-style-type: none"> <li>9-7/8" x 8-1/2" open hole</li> <li>14.0 ppg mud inside and out</li> </ul> </li> <li>Trip out with drilling assembly</li> <li>Wireline log for 4 days</li> </ul>

Interpretation
<ul style="list-style-type: none"> <li>Hole stable</li> </ul>

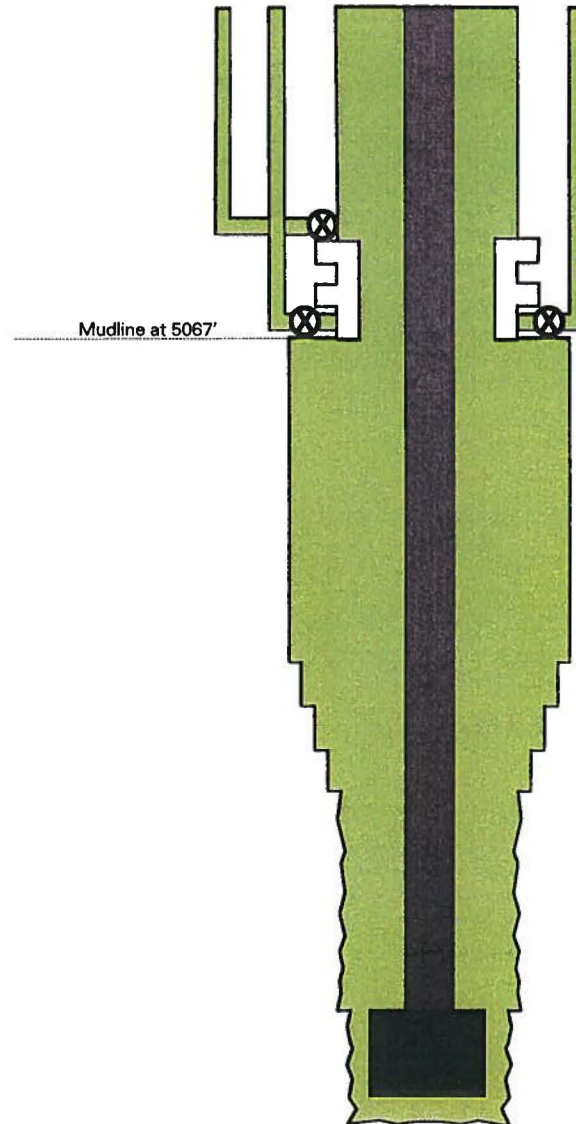
4/16/10 - 4/17/10

Function test BOP:  
4/17/10 at 01:00

Function test diverter:  
4/17/10 at 01:30

- Run in hole for wiper trip
  - Circulate bottoms up at TD
  - Pump high vis sweep
  - Monitor for gains or losses – none
  - 14.0 ppg clean mud throughout before trip out
- Pump out from 18360' – 14759'
  - 4 flow checks during trip out – no flow

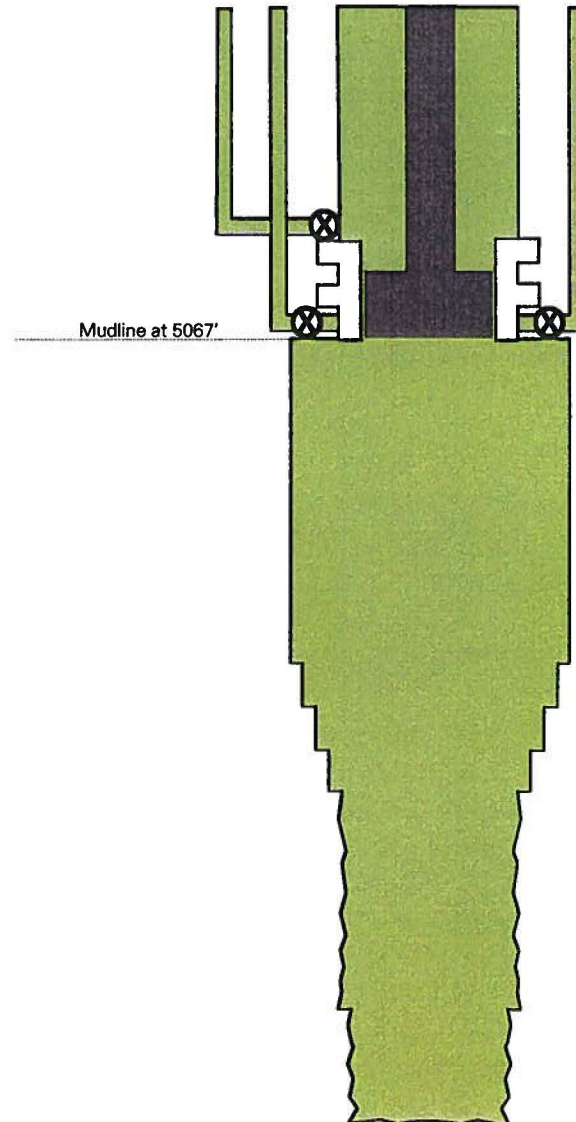
4/17/10 - 4/18/10

Function test BSR  
4/17/10 23:00

<u>Data</u>
<ul style="list-style-type: none"><li>• <b>Make trip to retrieve wear sleeve</b><ul style="list-style-type: none"><li>- <b>Retrieval successful</b></li></ul></li></ul>

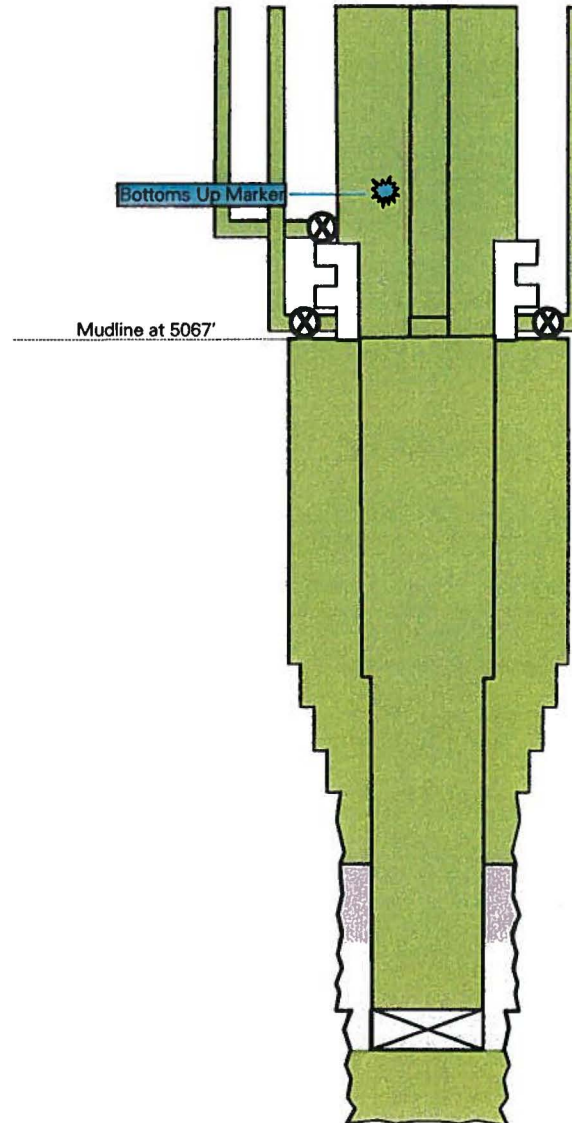
4/20/10

Close Upper VBR's to  
test seal assembly.  
Test successful

- Release running tool
- Set seal assembly at 5059' to seal the 9-7/8" casing annulus
- Successful pressure test of seal assembly
- Setting and testing procedure as per plan
- Begin tripping out

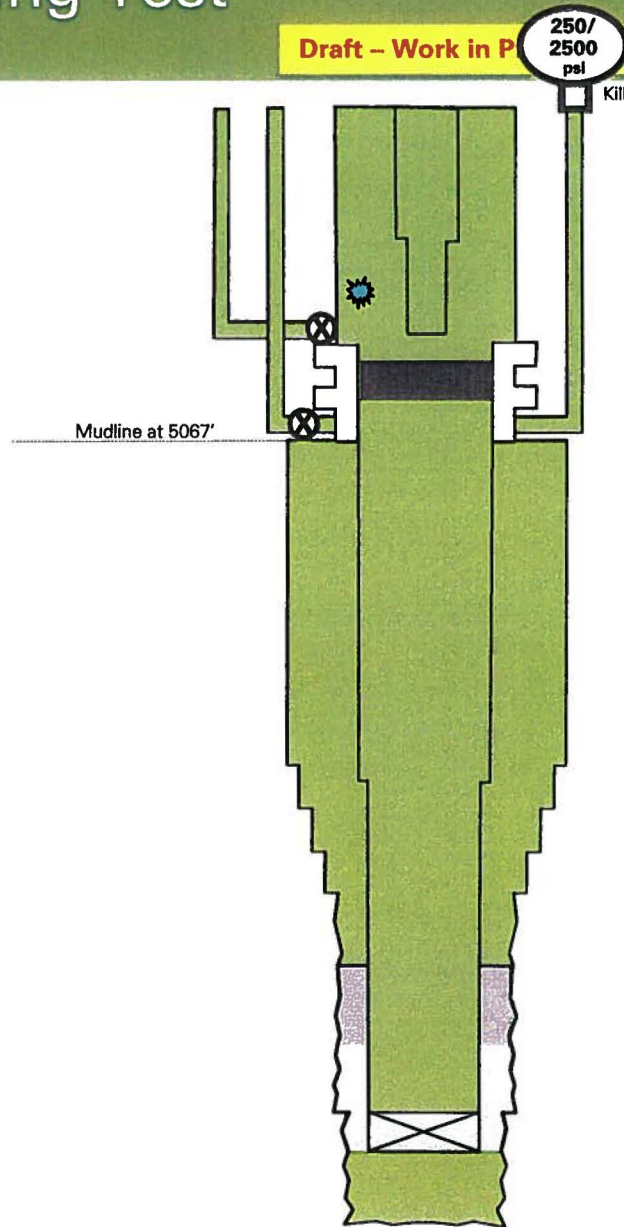
4/20/10

12:00 – Close BSR. Pump down kill line to test casing to 250/2500 psi for 30 min

Data
<ul style="list-style-type: none"><li>• Run in with tapered string for cement plug:<ul style="list-style-type: none"><li>– 6-5/8" x 5-1/2" x 3-1/2" drill pipe</li></ul></li><li>• Stop at 4700' (above BOP)</li><li>• Close blind shear rams</li><li>• Positive test casing to 250 and 2500 psi</li></ul>

Interpretation
<ul style="list-style-type: none"><li>• Positive casing test is successful<ul style="list-style-type: none"><li>– Pressures and volumes are as expected</li></ul></li></ul>

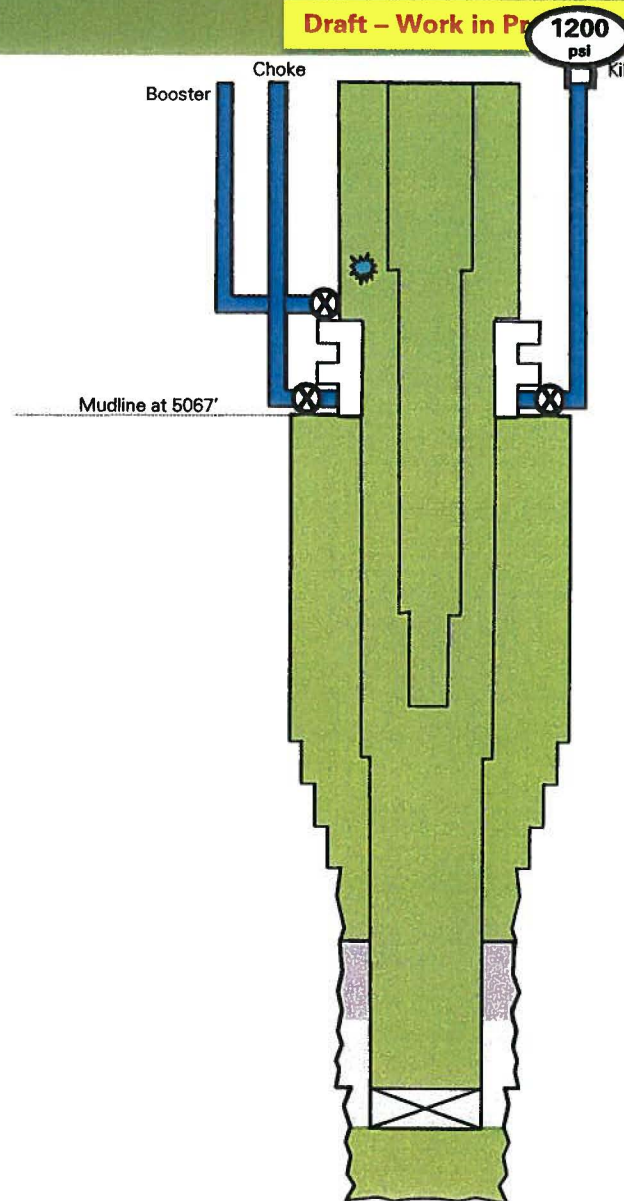
15:04 - 15:54

- Displaced booster line w/ seawater
- Displaced choke line with seawater
- Displaced kill line with seawater
- 1200 psi trapped in kill line

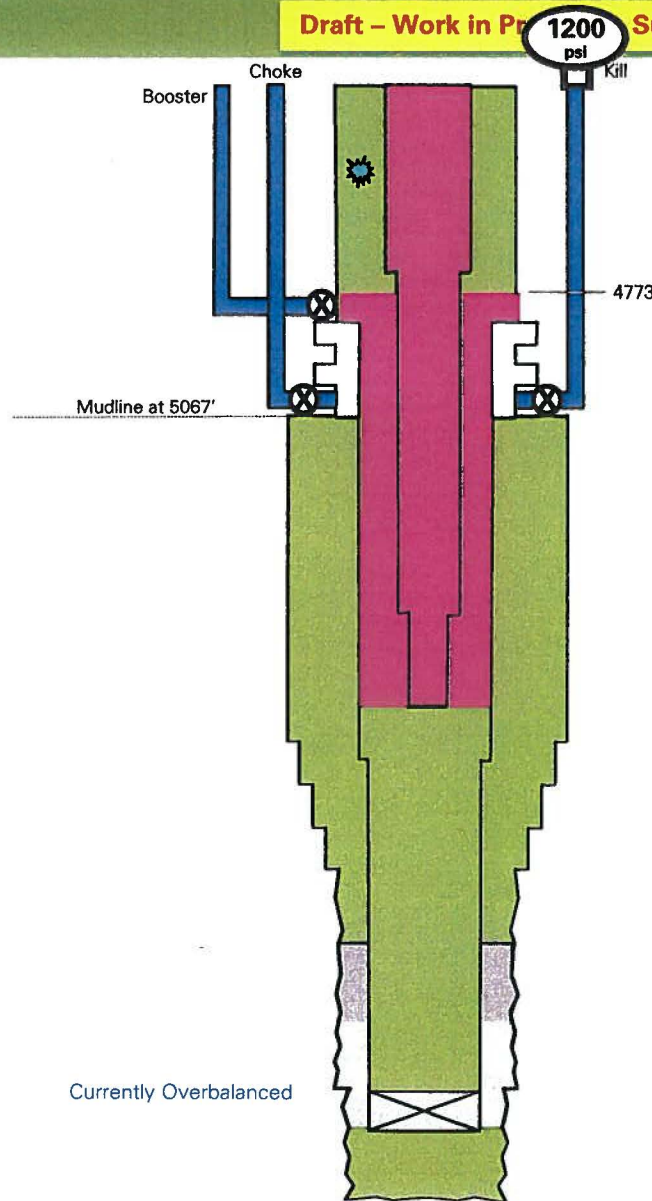
15:56 - 16:28

Data
<ul style="list-style-type: none"><li>• Pump 454 bbls LCM spacer (16.0 ppg)<ul style="list-style-type: none"><li>– Form-a-Set + Form-a-Squeeze combination</li><li>– Viscous, solids-laden fluid</li></ul></li><li>• Kill line pressure holds at 1200 psi</li></ul>

Interpretation
<ul style="list-style-type: none"><li>• Any gas from the cement job should be to surface by this point<ul style="list-style-type: none"><li>– No abnormal gas shows seen</li></ul></li></ul>

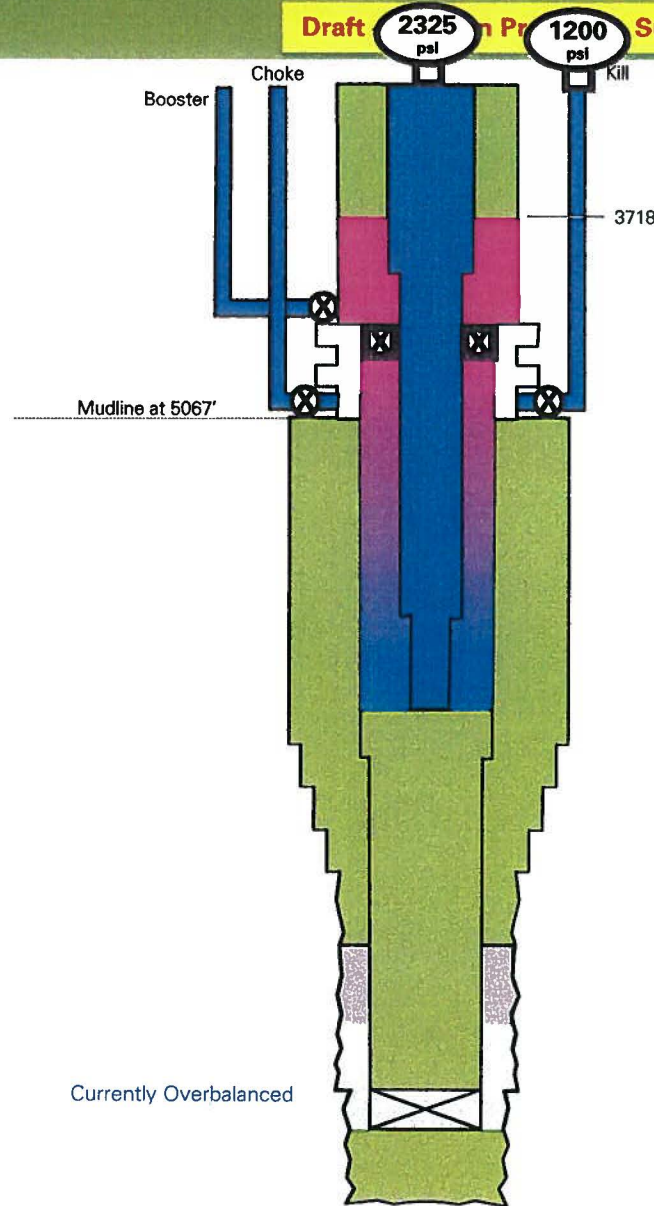
16:53 - 16:55

Data
<ul style="list-style-type: none"><li>Shut annular</li></ul>

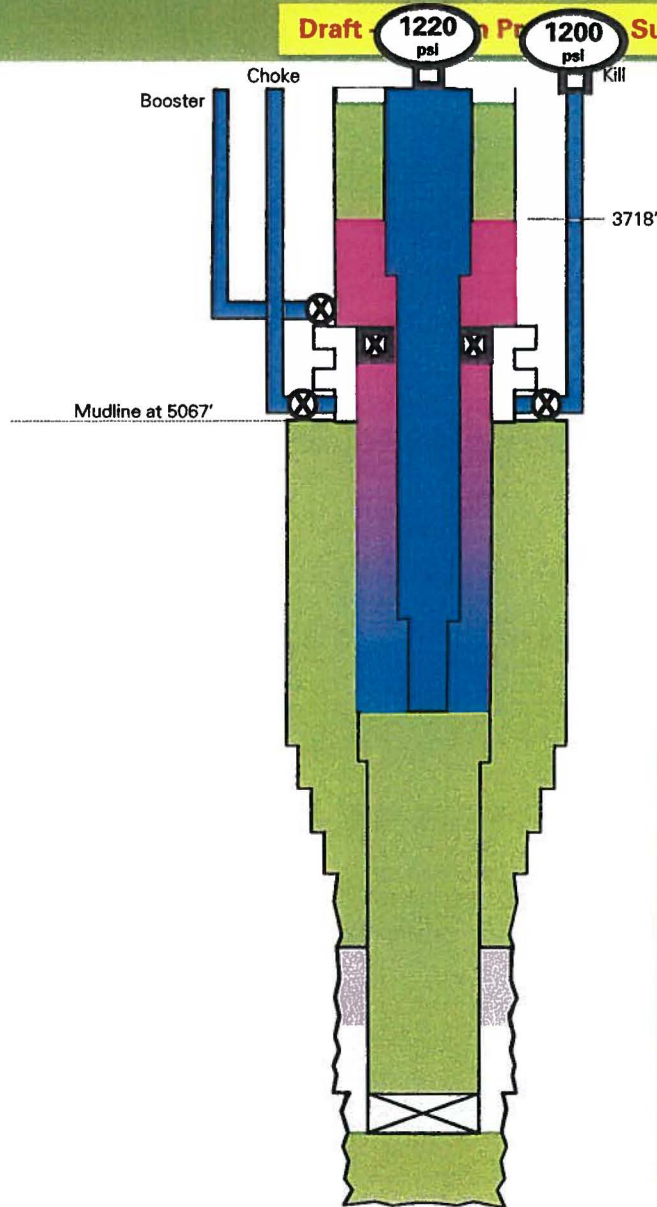
16:55 - 16:57

Data
<ul style="list-style-type: none"><li>Bleed drill pipe pressure from 2325 psi to 1220 psi to equalize with kill line</li></ul>

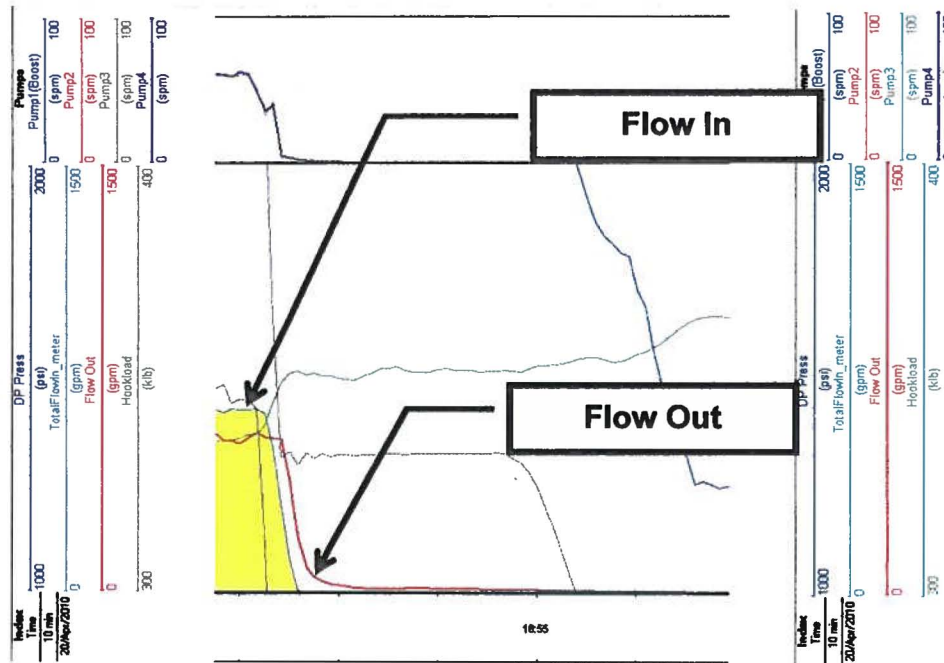
Ex) Normal Flow Back @ 16:52

- At 21:08 – pump shutdown as spacer observed at surface. Sheen test required.
  - Flow-out should be zero, but real-time data indicates well flowing after pump shut off
  - Drillpipe pressure increased from 1017 psi to 1263 psi over 5.5 minute period of sheen test

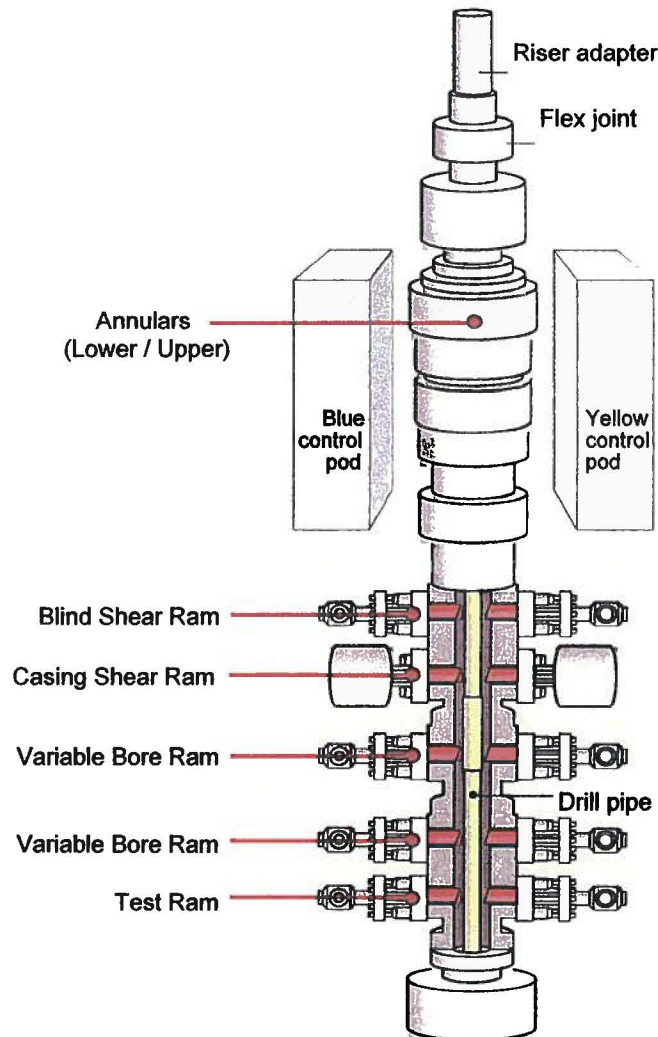
# BOP Function Description

- **UAP** Upper Annular Preventer used in normal drilling operations for well shut-in rated 10K.
- **LAP** Lower Annular Preventer with Casing Stripping Element.. Used for casing stripping purposes, down rated to lower wellbore retaining pressure 5K.
- **BSR** Blind Shear Rams Cuts drill pipe and seals the well.
- **CSR** Casing Shear Rams Non-Sealing, cuts drill pipe and casing; is not designed to seal the wellbore.
- **UPR** Upper Pipe Rams Ram packers can close on a range of drill pipe from 3 ½" OD to 6 5/8" OD and seal up to 15K wellbore pressure.
- **MPR** Middle Pipe Rams Ram packers can close on a range of drill pipe from 3 ½" OD to 6 5/8" OD and seals up to 15K wellbore pressure, can also be stripped through to hang-off drill pipe up 600K
- **LPR** Lower Pipe Rams . Test Ram seals up to 15K pressure from above.

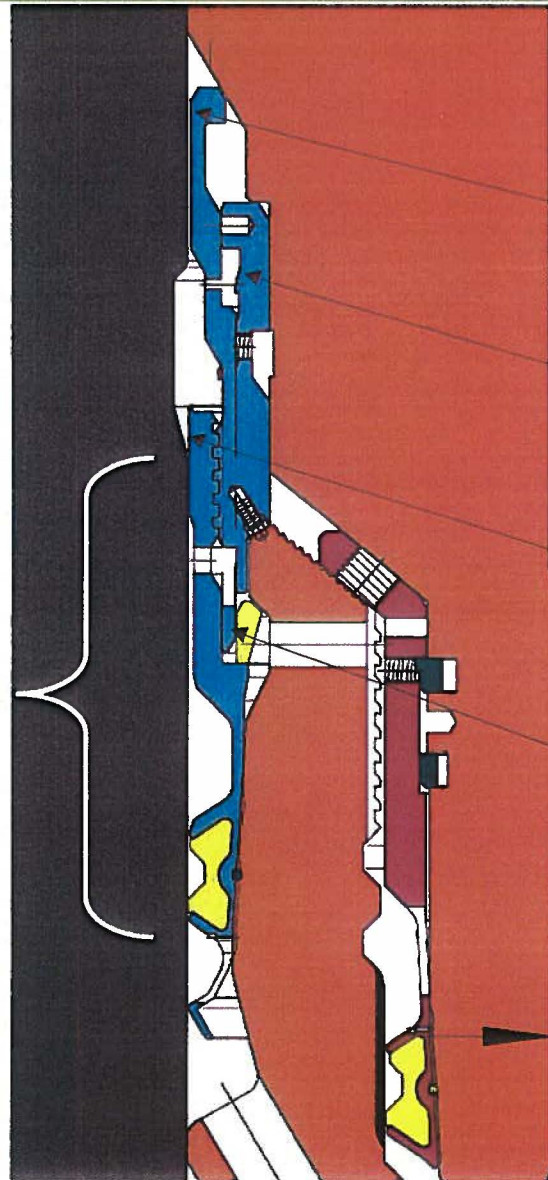
# Seal Assembly Cross Sectional View

- Cement failed to isolate the reservoir
- The float collar (1) or the seal assembly (2) leaked
